NATIONAL BUREAU OF STANDARDS REPORT

NBS REPORT
7036

Progress Report

CHANGES IN DENTURES DURING STORAGE IN WATER AND IN SERVICE

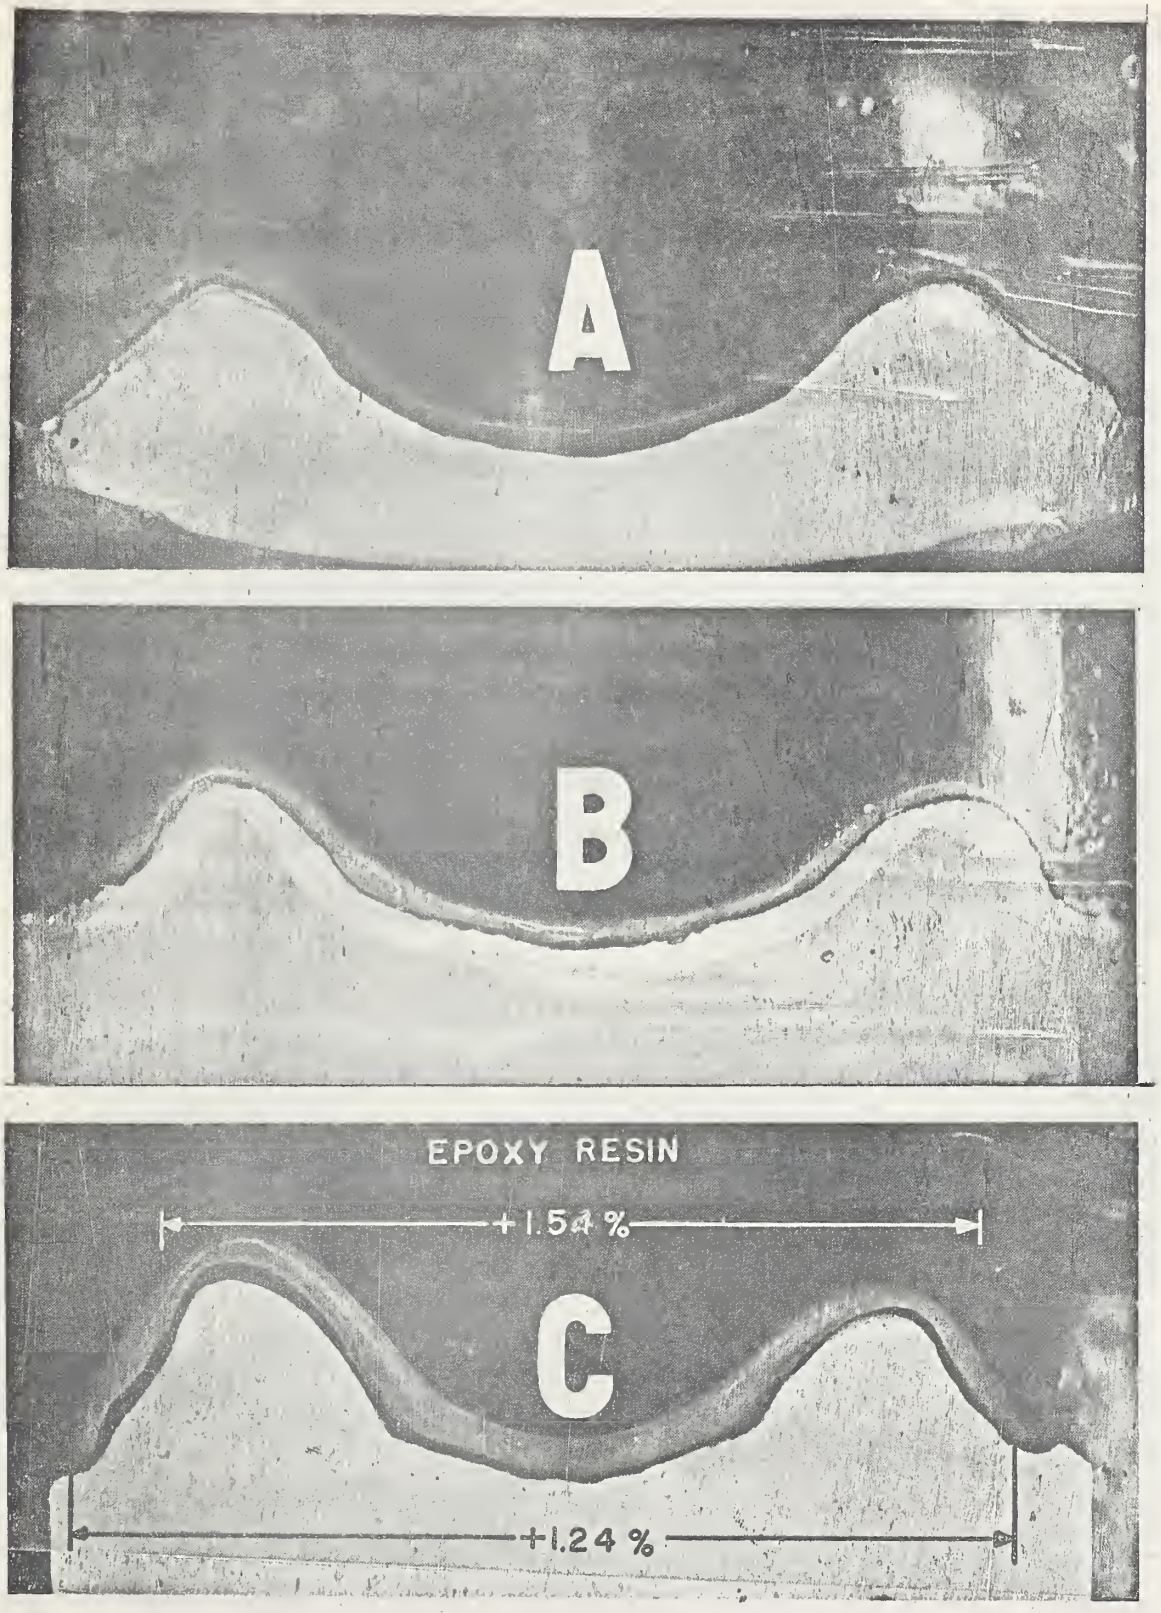
Figure 7 shows clinical upper dentures which were 24 months old seated on the gypsum casts on which they were cured. Denture A, made of a self-curing acrylic resin, had very low molar-to-molar (0.03%) and flange-to-flange (0.06%) expansion. Consequently, Denture A fits the cast remarkably well. Denture B, made of a heat-curing acrylic resin, had low molar-to-molar (0.18%) and flange-to-flange (0.11%) shrinkages. The degree of fit is only slightly less than in Denture A. In Denture C, made of an epoxy resin, the gross expansions (molar-to-molar, 1.5%, and flange-to-flange, 1.24%) are reflected in the poor fit of the denture on its cast.

Some of the minute discrepancies in fit shown in Dentures A and B (Figure 7) occurred during processing and polishing before the patients had the dentures. In contrast, practically all of the dimensional changes occurring in Denture C came while the denture was in use. Denture C continued to fit the mouth well because the very large expansion occurred slowly; thus the tissues were able to adapt. The refitting of a denture on its

The examples of the fit of upper dentures (Fugure 7) are typical of the 14 uppers where the casts on which they were processed could be recovered. The original casts of nine clinical lowers, which had dimensional discrepancies similar to those of the uppers, were recovered. These lower dentures usually fit their casts better than the uppers after 24 months of service.

If the fit of the denture on the cast on which it was processed is not as accurate as that shown by Denture B (Figure 7) one should look for errors in technic or faults in the resin base.

Figure 7. Relationship between the fit of upper clinical dentures on the gypsum casts on which they were cured and changes in molar-to-molar and flange-to-flange distances. All of the end measurements were obtained after twenty-four months in service. The fiducial measurements were made with the deflasked dentures on the cast except in the flange-to-flange measurement on denture A. Here the fiducial measurement was made on the denture removed from the cast.

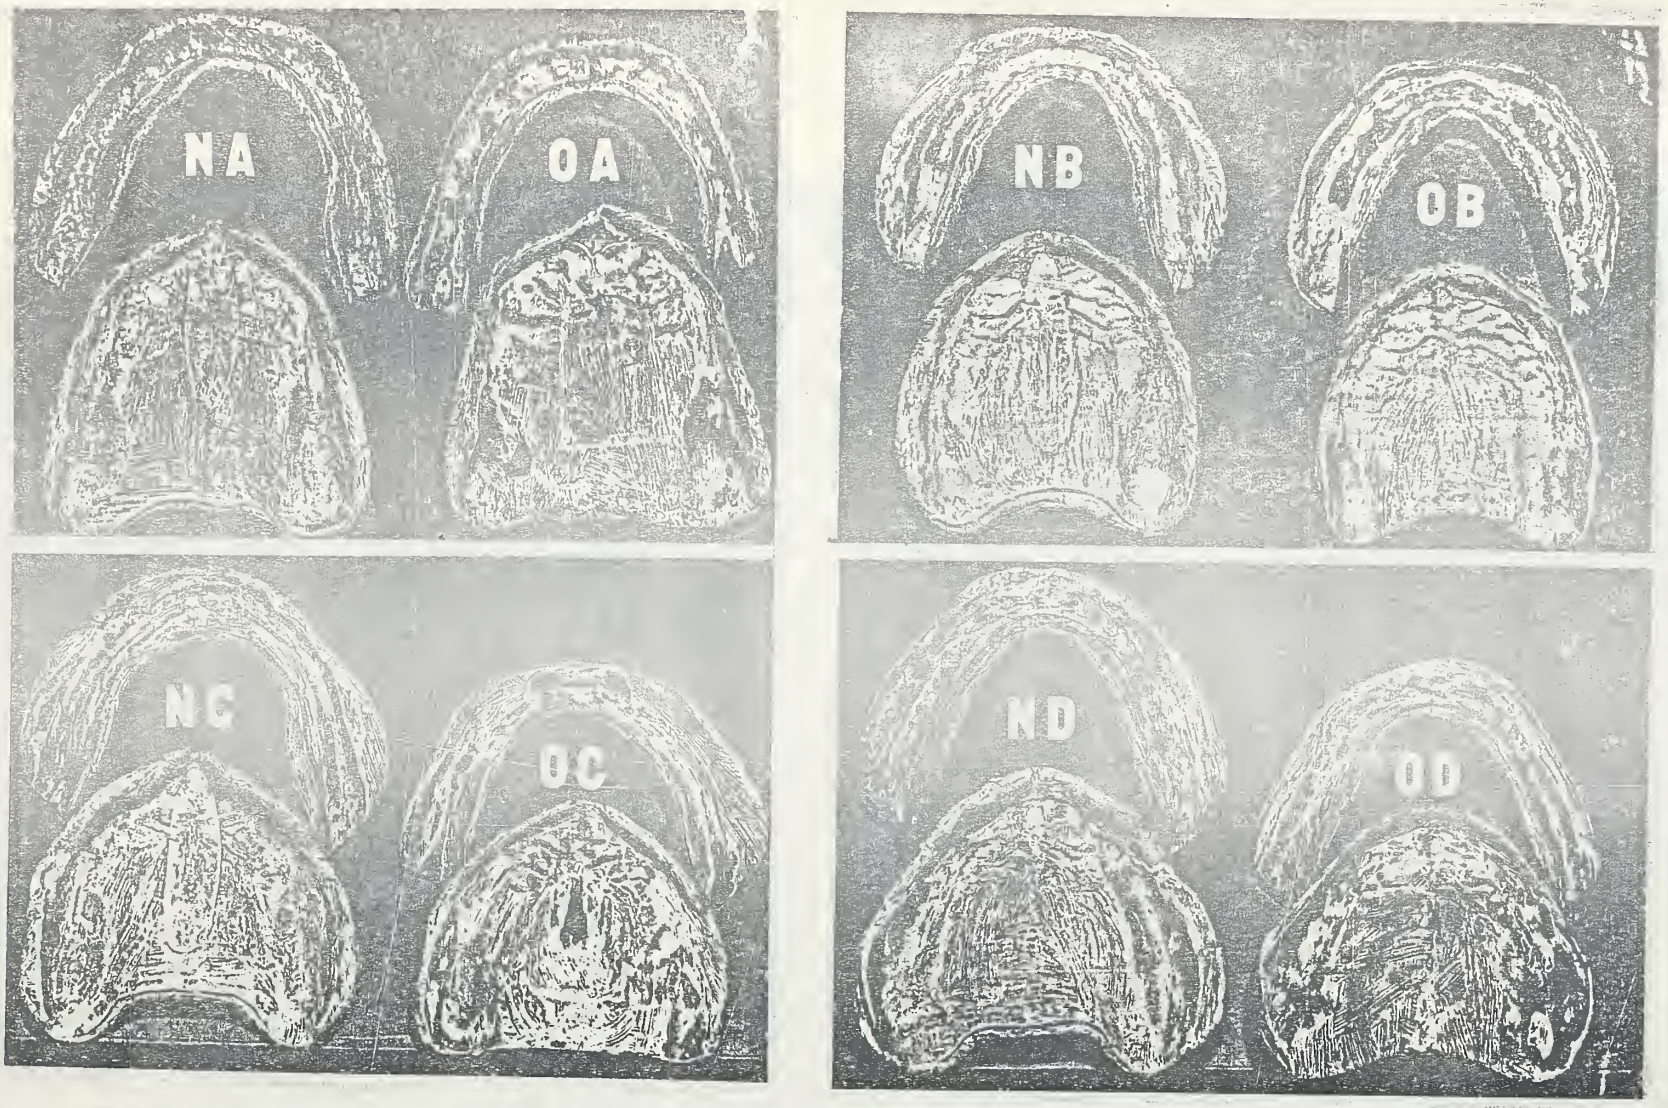
of a pressure-indicator paste*, sprayed with an emulsion furnished with the paste, inserted under heavy manual pressure, removed and photographed. In all instances, the new dentures showed a more uniform contact with the oral tissues than the old dentures. Typical patterns of the variation in contact with the tissues are shown in Figure 8. There was no relationship between the type of resin or method of processing and the patterns. There was a definite correlation between the fit of the new and the old dentures and the pressure-indicator paste patterns of the new and old dentures. In some instances this test revealed discrepancies in the fit of the new dentures that neither the patient nor the dentist had been aware of. Adjustments on these dentures were made by removing a thin film of resin from the area or areas of heavy content. Such a recall system might be advisable periodically for all denture-wearing patients.

Figure 8. Pressure indicator paste patterns of new (NA, NB, NC and ND) dentures and old (OA, OB, OC and OD) dentures. The new dentures are made of compression-molded acrylic resin (NA): an epoxy type of resin (NB): An injection-molded acrylic resin (NC): and a polystyrene (ND). All of the old dentures appeared to be acrylic resin except the upper OD which was vulcanite. The dark areas show evidence of heavy contact. In the old upper dentures bilateral heavy contact was found, with few exceptions, on the posterior part of the ridge, especially the crest of the ridge near the tuberosity. In the old lower dentures the areas of heavy contact were usually bilateral and mostly on the crest of the ridge.

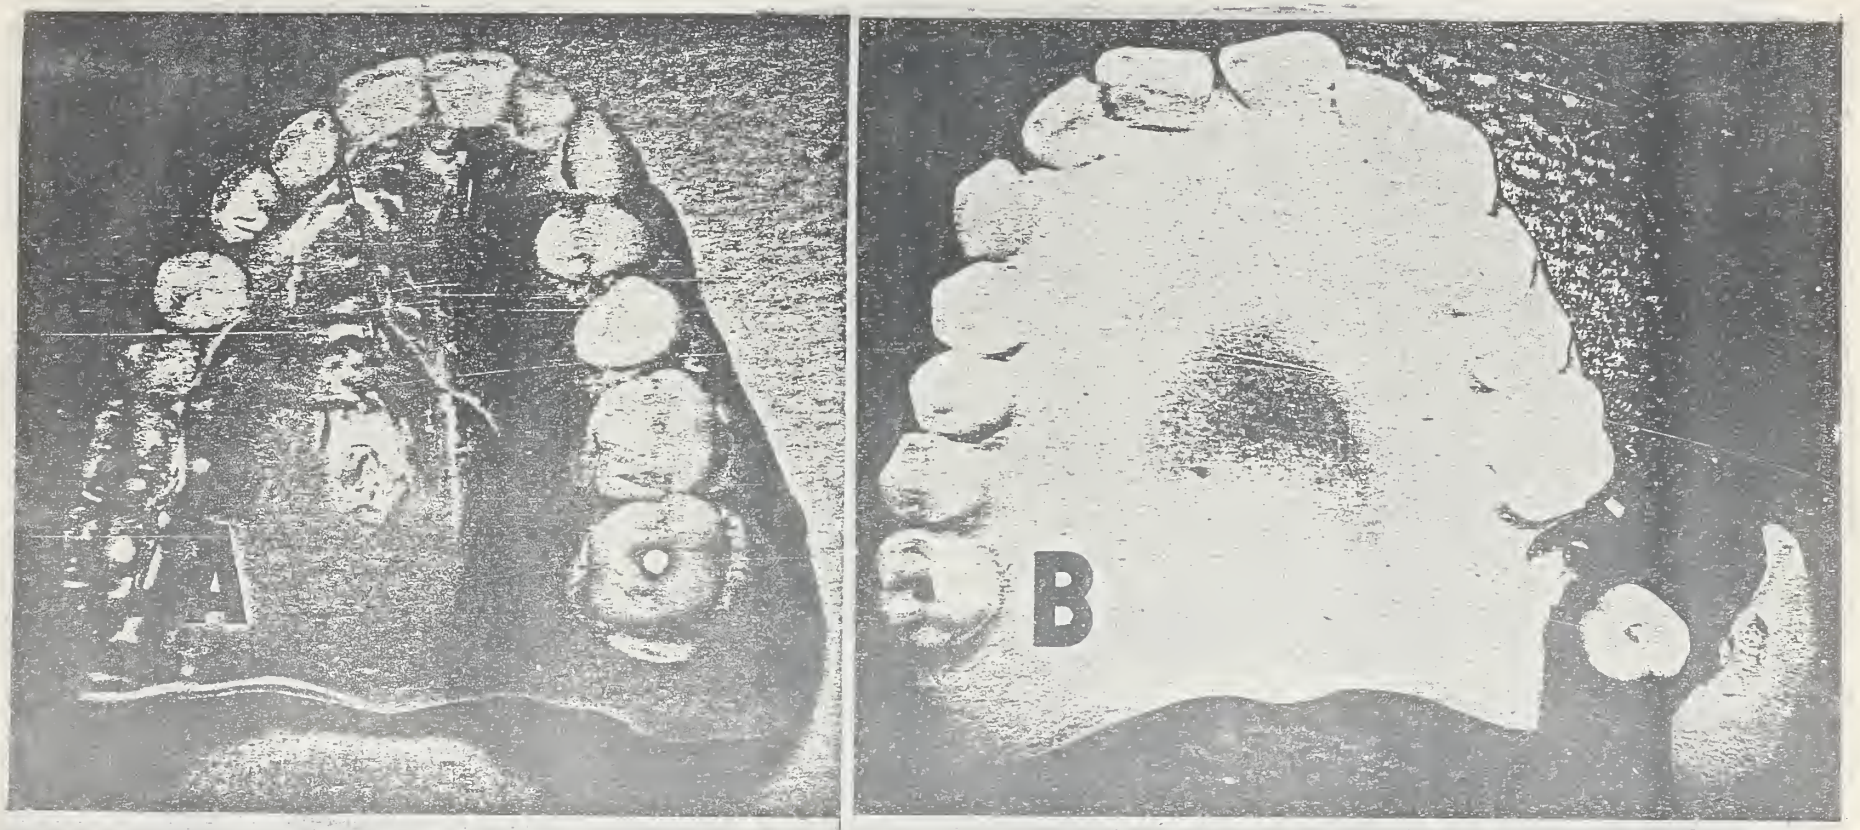
Out of 73 clinical dentures three were broken. Figure 9A shows a crack in a Jectron upper denture that was opposed by lower natural teeth. The crack developed in use after fifteen months. Denture B in Figure 9 was also opposed by natural teeth. According to the patient the disto-buccal flange was broken off this denture, made of Vernonite (powder-liquid type), when the patient bit on a piece of hard caramel candy which was lodged between the natural lower third molar and the buccal flange of the upper denture. This denture was 23 months old when the break happened. Another upper denture of Vernonite, also opposed by natural teeth, was fractured when the patient was struck in the mouth.

Three out of 73 clinical dentures broke. All were uppers opposed by natural teeth. One fracture of an acrylic resin denture was caused by a blow. In another acrylic resin denture the buccal flange was broken off in chewing. There was a typical mid-line fracture in one polystyrene denture.

Figure 9. Shown in A is a typical midline fracture in a Jectron upper denture opposed by natural teeth. This crack extending through the labial flange developed after 15 months of use. In B a fracture that occurred in a Vernonite (powder-liquid type) upper denture opposed by natural teeth. This broke when the patient bit on a piece of hard caramel candy which lodged between the natural lower third molar and the buccal flange of the upper denture. Denture B had been in service 23 months when the break occurred.

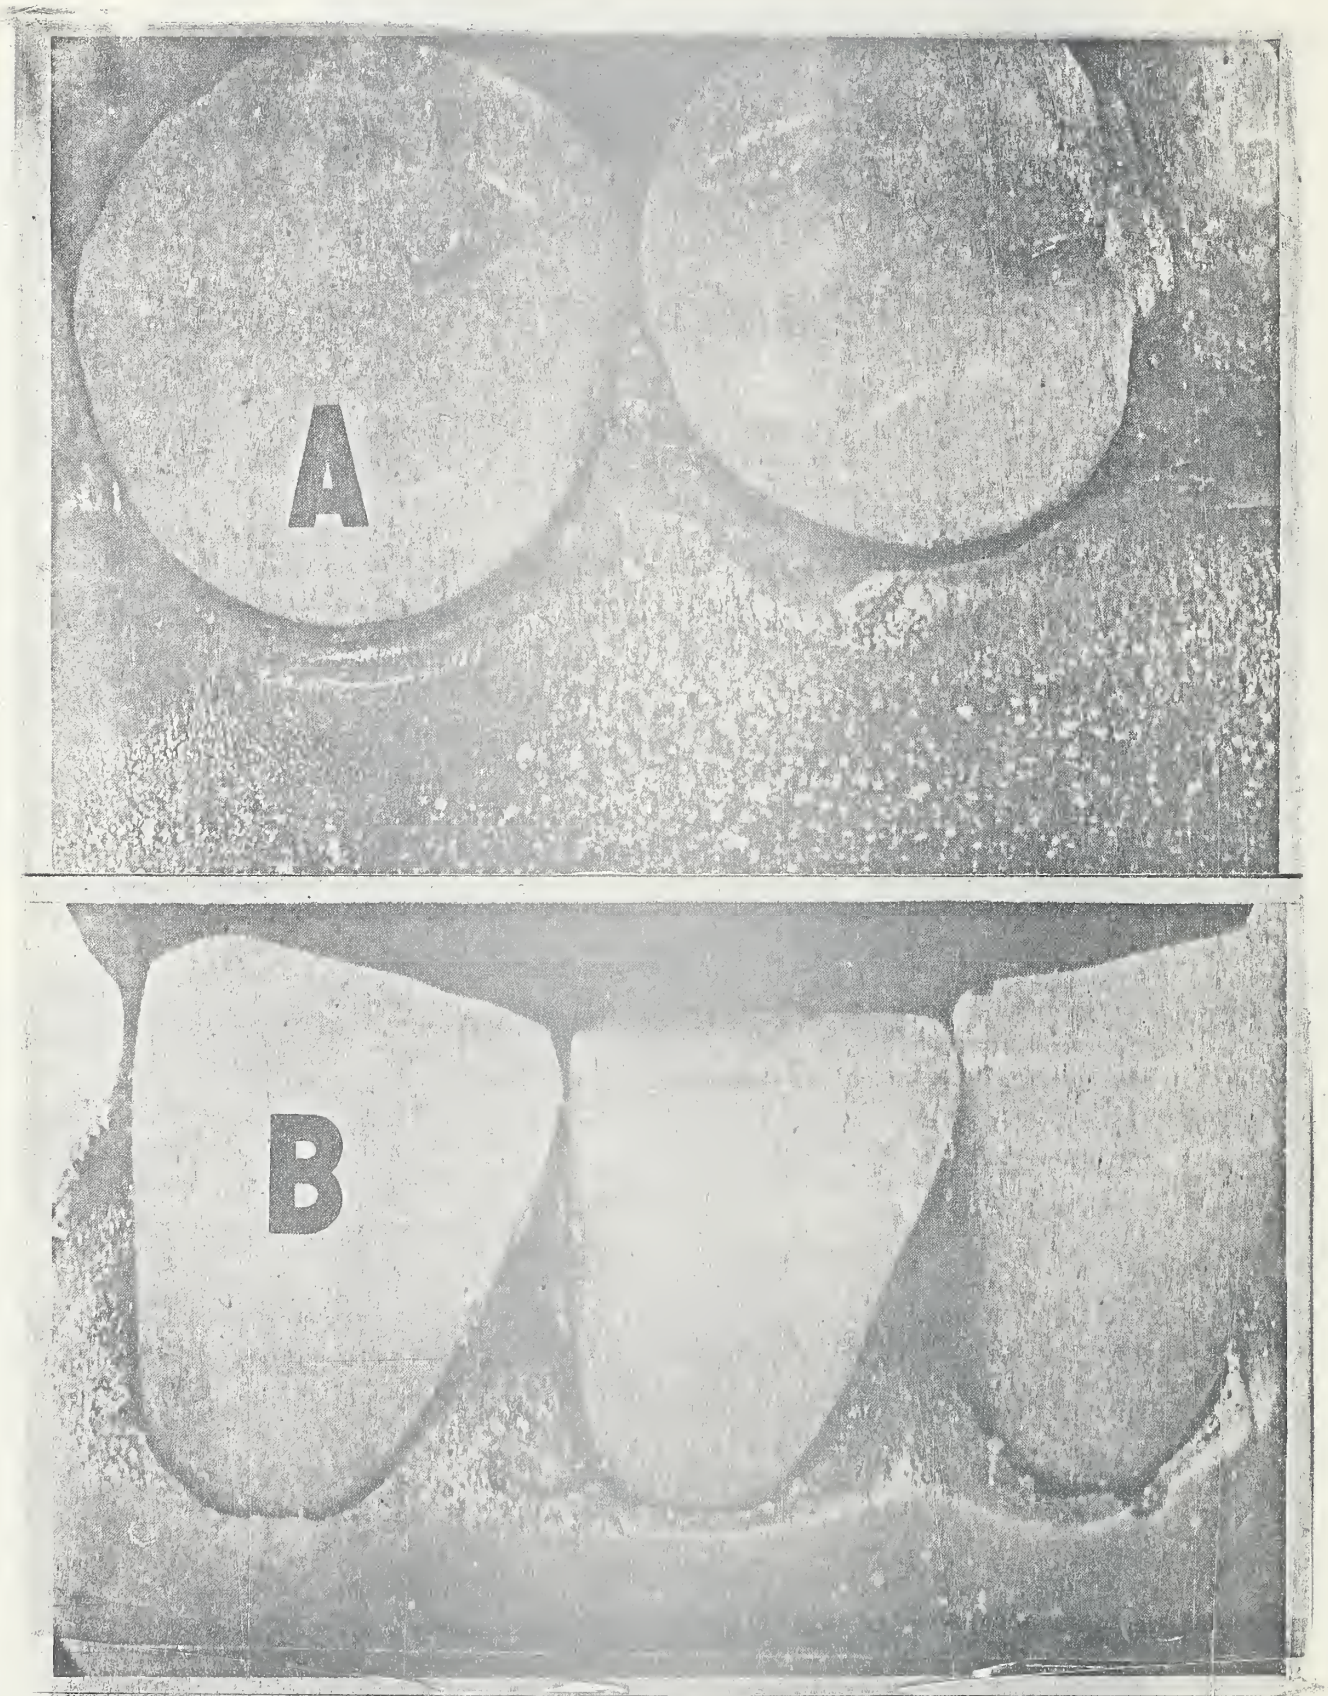
No teeth came out of any of the dentures except those made of Epoxolon. After only 15 months, the eight clincal dentures of Epoxolon had lost 31

porcelain posterior teeth. The posterior teeth came out of the dentures because of a crevice developed around them (A in Figure 10). The crevices also occurred around the anterior teeth (B in Figure 10) but none were lost during the first 15 months, probably because of the additional retention furnished by the metal pins in the anterior teeth. The crevices developed as the dentures swelled in contact with the saliva. Naturally, the crevices, coupled with the porosity (A and B in Figure 10), made the dentures very unhygienic.

Figure 10. Epoxolon dentures showing separation of teeth from the base resin. Upper denture A and lower denture B were in service 17 months when the two left upper molar teeth were lost. Spaces observed around the bicuspids (A) and the anterior teeth (B) were caused by expansion of the functioning epoxy resin denture in contact with saliva. No molding pressure was used in packing or curing so the porosity evident in (A) and (B) frequently occurred in the areas of thick cross-section.

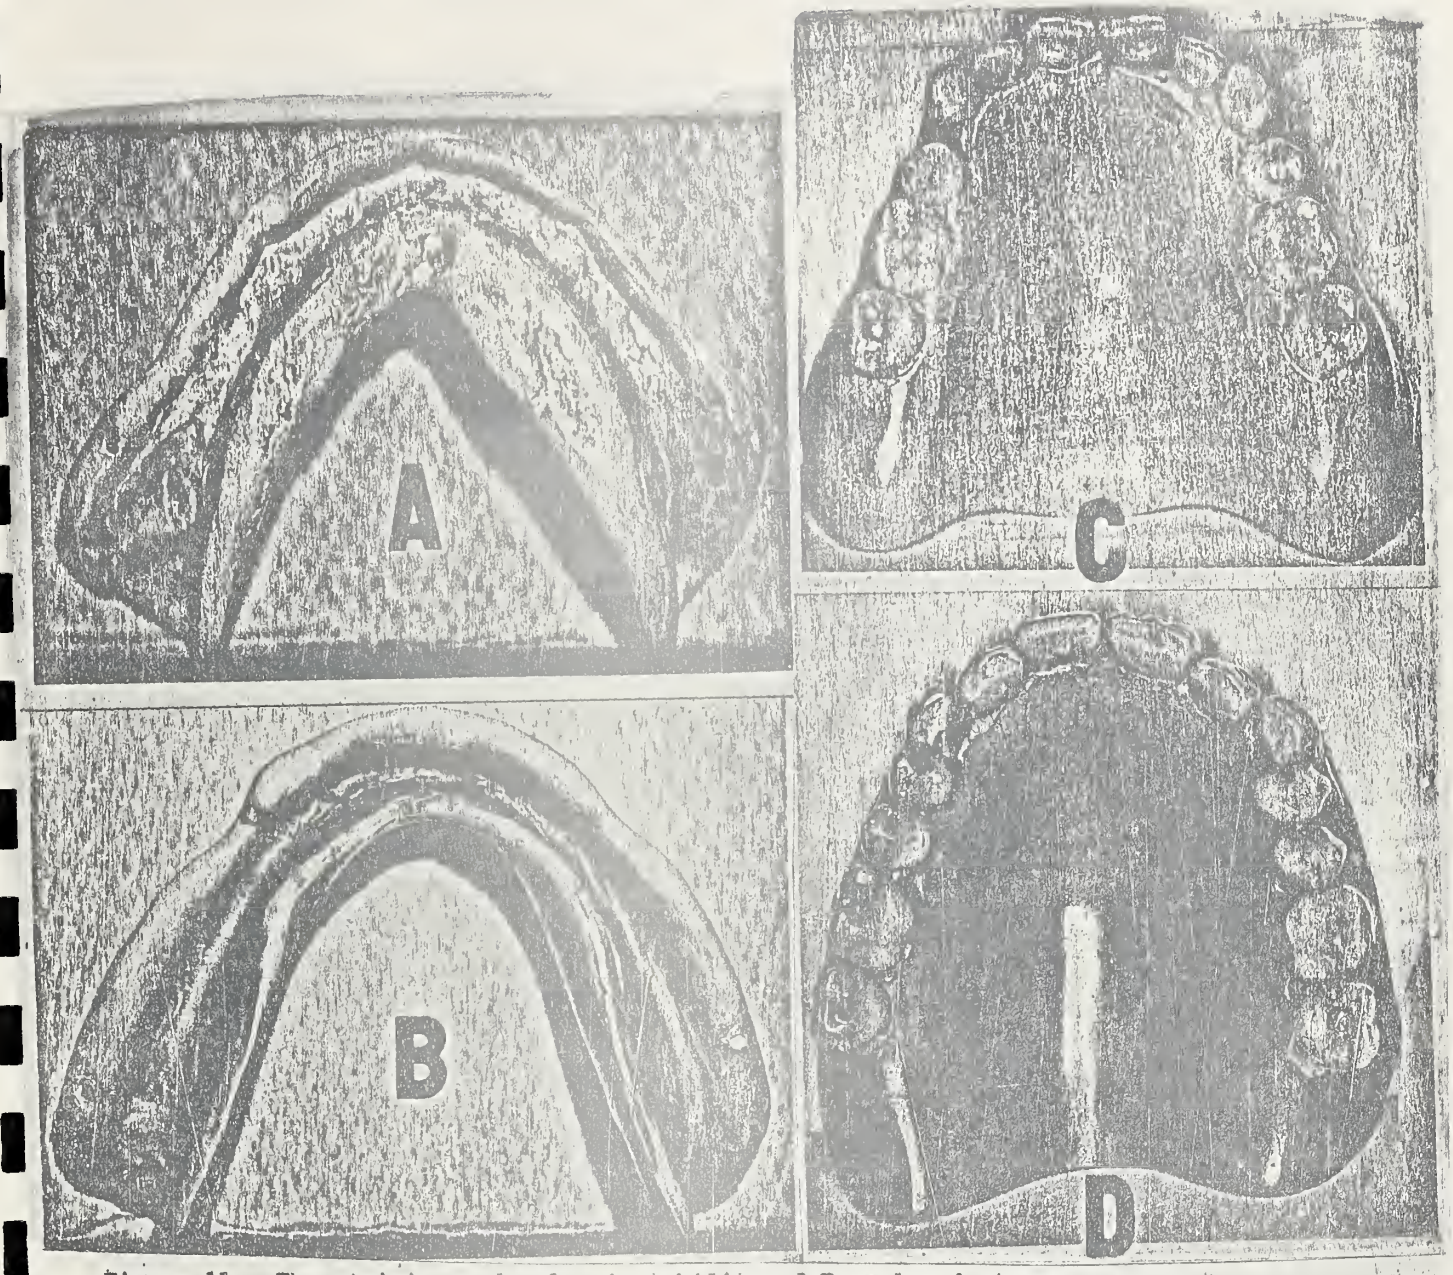
Clinical dentures of Epoxolon showed a marked tendency to collect quickly stains, such as lipstick and, particularly, tobacco stains. The patients complained that these dentures were more difficult to keep clean than their previous dentures. The tendency of Epoxolon dentures to stain rapidly and easily is vividly shown in Figure 11. Here A is a heat-curing acrylic resin denture that the patient had worn for eight years with no other treatment than cleaning at home. Denture B is an Epoxolon denture

after one week's use by the same patient who formerly wore acrylic resin Denture A.

Epoxolon was the only denture base resin, among the 12 types used, that did not comply with the color stability test of American Dental Association Specification No. 12 for Denture Base Resin. Likewise the clinical dentures of Epoxolon were the only ones that were not color stable in use (D in Figure 11). This presents another example of the unusual validity of the color stability test in the specification.

Figure 11. The staining and color instability of Epoxolon dentures.
Denture A, made of a heat-curing acrylic resin, had been worn by the patient for eight years. Only slight staining and calculus deposits are present. Denture B, made of Epoxolon for the same patient, shows the unusual amount of staining that occurred in one week's use. Most of the stain on all of the dentures appeared to be tobacco tar.
The Epoxolon dentures shift from tissue pink to an organge tint both in the lamp test for color stability described in the American Dental Association Specification No. 12 for Denture Base Resins, and in actual use (D).
Denture (C) was made of heat-cured acrylic resin that had been in service for 28 months and was not repolished. Denture (D) was made of Epoxolon and was repolished after 29 months of service. The color of the Epoxolon denture (D) at the time it was given to the patient was approximately the same as that of the heat-cured acrylic resin (C) used in this comparison.
